**OFF-SITE AREA FINAL ENGINEERED COVER
CONSTRUCTION COMPLETION REPORT**

**AMERICAN CHEMICAL SERVICE, INC.
NPL SITE
GRIFFITH, INDIANA**

MWH File No. 2090601

JUNE 28, 2004

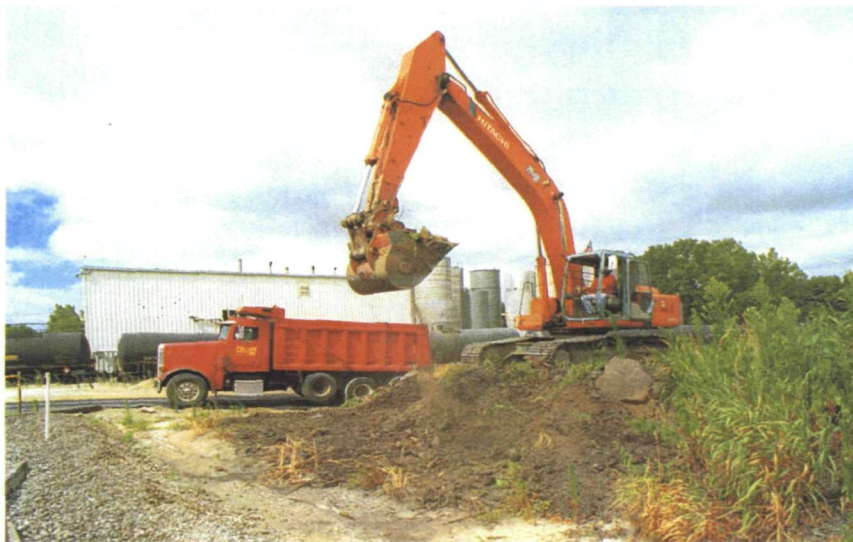
1. July 2002 (Looking South): An excavator loads PCB-impacted material from the Former On-Site Area Fire Pond into a dump truck. The dump truck has backed up to the stockpile on a geotextile mat to prevent potential tracking of material out of the work area.

PCB-impacted material was transported from the Former Fire Pond Area to the Off-Site Area using dump trucks loaded by an excavator. The dump trucks drove through the gate connecting the On-Site and Off-Site Areas where the material was unloaded into Swale 5 and graded smooth with a bulldozer in one 12-inch lift. Photographs 1 and 2 in Appendix B show the transportation of the PCB-impacted materials. The material was then compacted using a smooth drum vibrating roller in preparation for the replacement of the clay layer. Photographs 3 and 4 in Appendix B show the placement and compaction of the PCB-impacted materials.

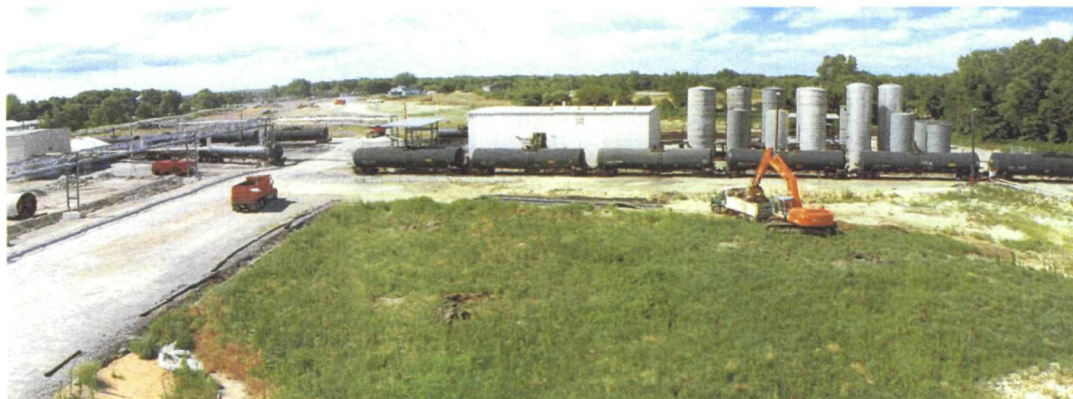
2. July 2002 (Looking South): PCB-impacted material is transported from the Former Fire Pond (foreground) to the Off-Site Area (background) for placement under the final engineered cover.

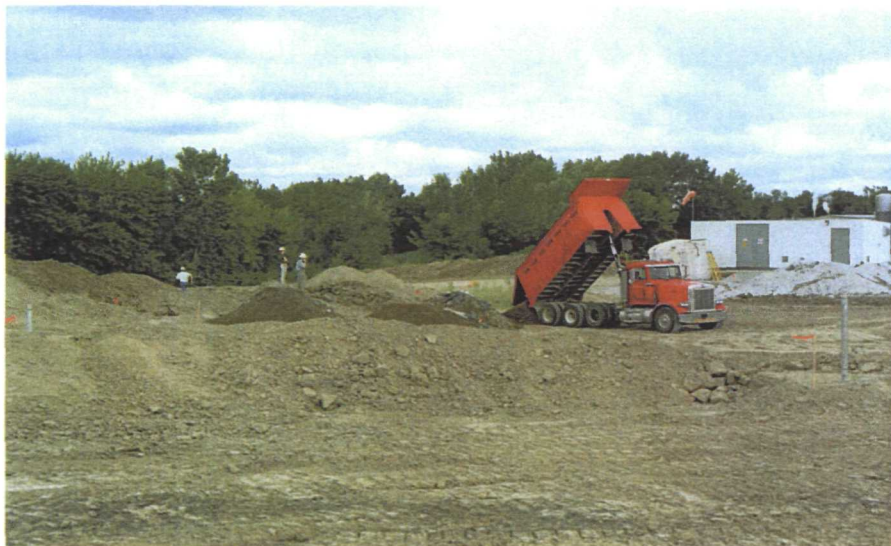
3. July 2002 (Looking Northwest): PCB-impacted material is placed in drainage Swale 5. Prior to material placement, the top 12 inches of clay was removed and stockpiled for later use.

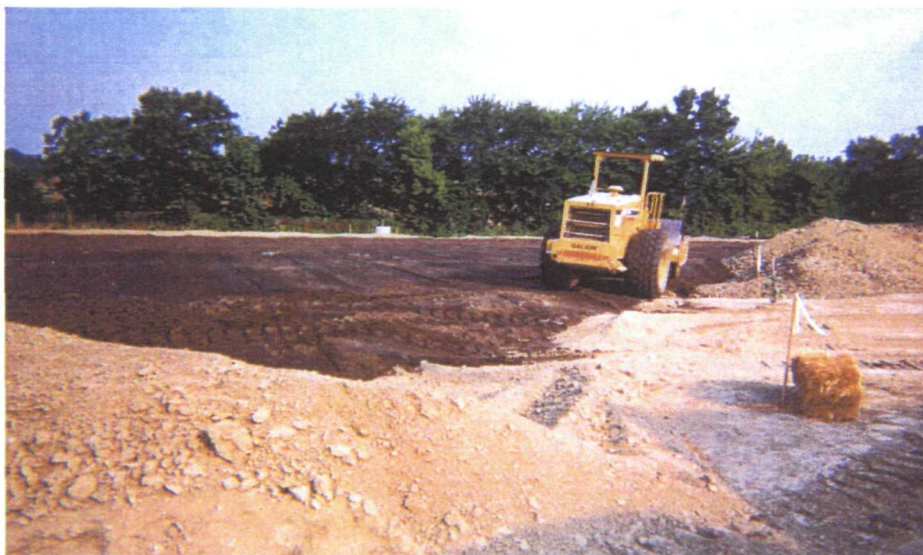
4. July 2002 (Looking West): A smooth drum roller compacts the newly-placed PCB-impacted material.

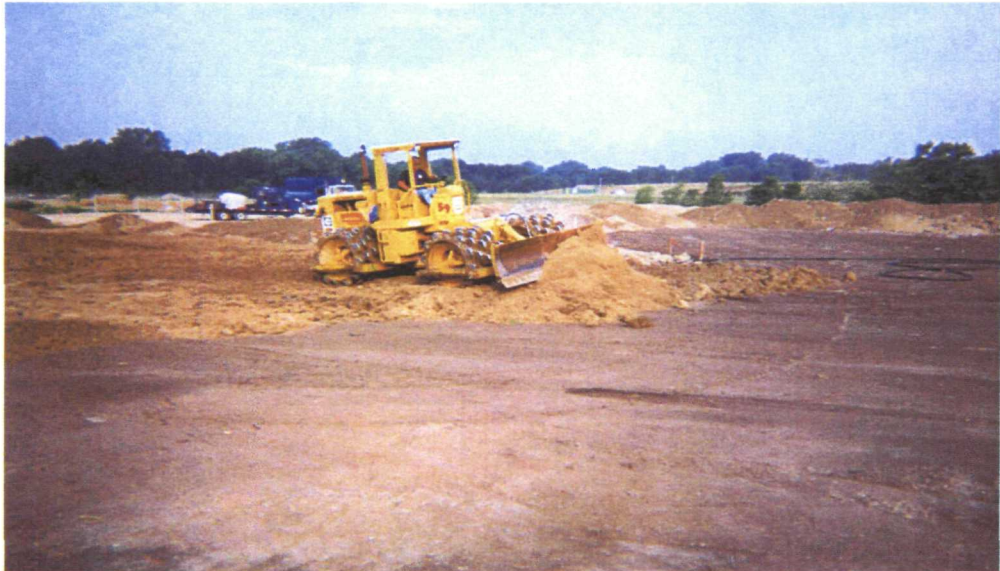
5. July 2002 (Looking Southwest): A sheep-foot/dozer combination machine spreads and compacts 12 inches of clay over the PCB-impacted material in two six-inch lifts.

After the PCB-impacted material had been placed in Swale 5 to the determined grade, the 12-inch clay layer was then replaced and compacted on top of the PCB-impacted material in two six-inch lifts. Additional clay was imported from the same Merrillville, Indiana clay source as was used during the 2001 Interim Engineered Cover activities to supplement the clay that had been removed.

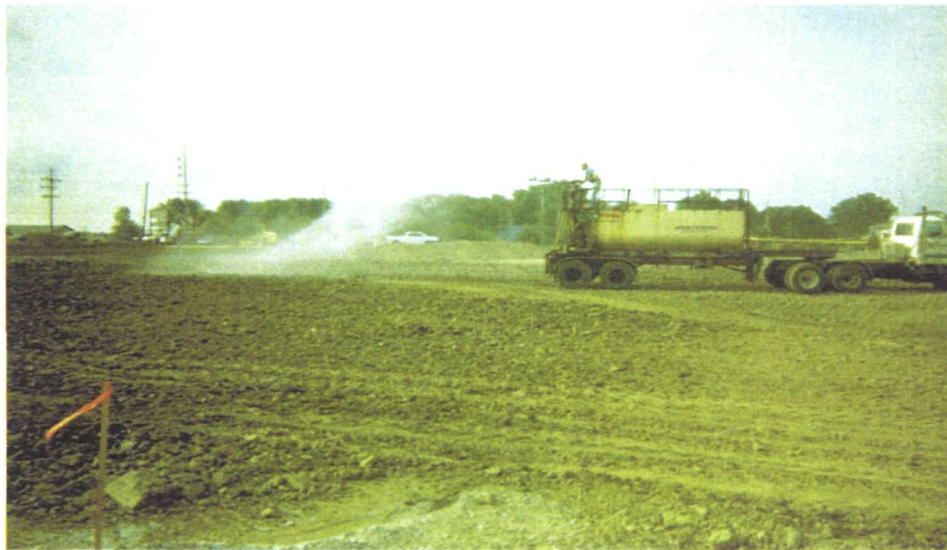
6. July 2002 (Looking Southeast): A water truck wets the clay to aid in compaction.

The clay was wetted as needed and compacted with a sheep's foot compactor and a smooth-drum roller until the compaction and moisture requirements for the interim clay cover were met. The compaction requirement for the clay was 95 percent of the maximum dry density of 115 pounds per cubic foot (pcf). The moisture requirement for the clay was 17 percent plus or minus 2 percent. Photographs 5 and 6 in Appendix B show the compaction efforts of the clay placement. The compaction and moisture testing was performed by Great Lakes Soil & Environmental, Inc. (Great Lakes). Compaction test results are included in Table 1. MWH measured final clay thicknesses in this area to confirm that sufficient thicknesses were achieved. The average measured clay thickness was 12 to 12.25 inches as shown on Table 2. However two measured thicknesses were less than 12 inches, one at 10 inches and the other at 11 inches. MWH determined that these two locations of deficient clay would not result in a significant increase in the infiltration rate. In addition, the flexible membrane layer (FML) was installed to provide the main barrier to infiltration with the clay only providing a secondary barrier. Based on the relatively small size of these potentially deficient areas, MWH determined that performing permeability testing at these locations was not necessary and that the overall clay thickness of the area was calculated to meet the project's hydraulic conductivity requirements for clay placement, based on average thickness.

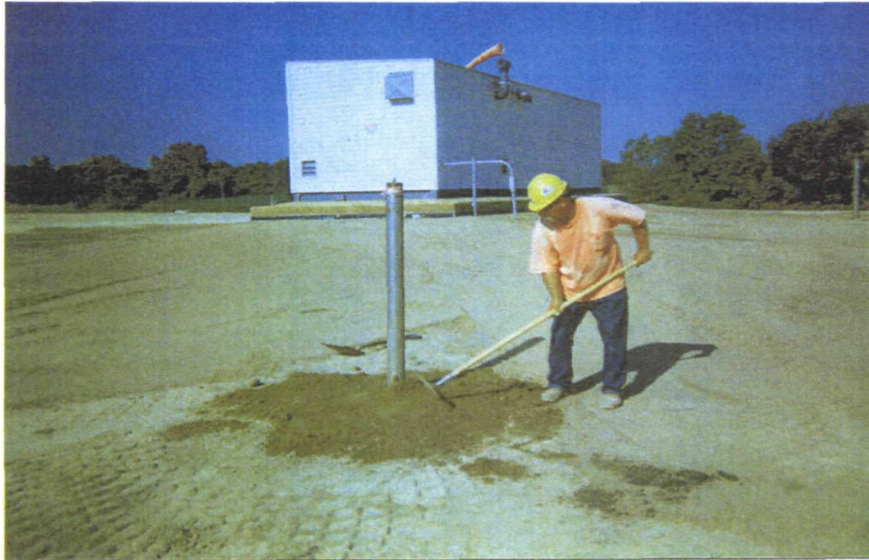
7. August 2002 (Looking West): Small mounds of sand are placed around each SVE and groundwater monitoring well prior to liner installation to ensure water will not collect around the wells.

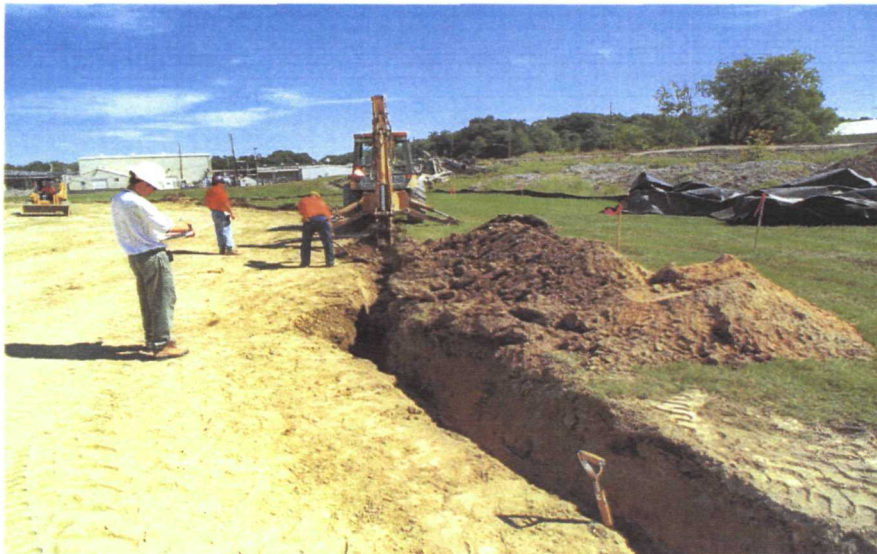
8. September 2002 (Looking North): A backhoe with a narrow-bucket is used to dig a two-foot deep anchor trench around the perimeter of the FML liner area. Air monitoring is conducted during the trenching process.

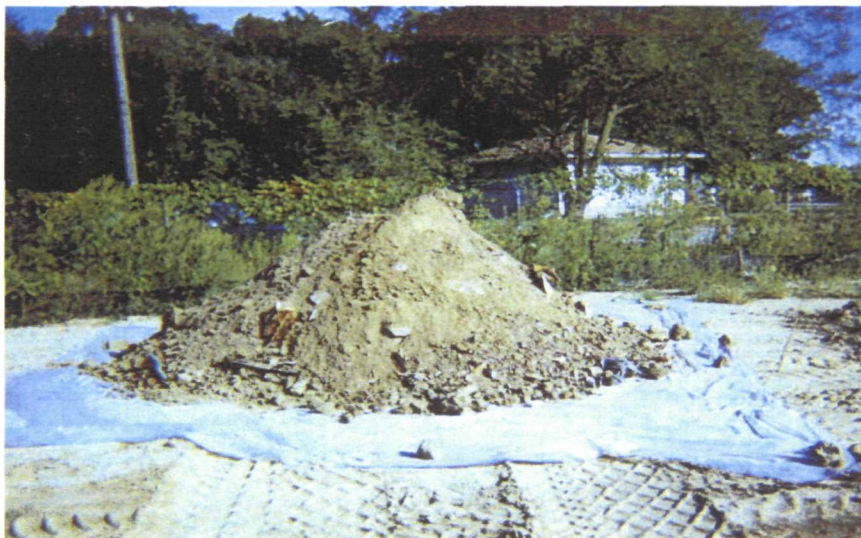
9. September 2002 (Looking East): Construction and household debris excavated during the anchor trench construction is stockpiled on a poly liner and covered. This material is later transported to the On Site Area for placement under the On-Site Area Interim Engineered Cover.

As the anchor trench was being excavated, soil that was observed to contain debris or other visual indications of potential contamination was separated from the rest of the excavated material and stockpiled on plastic sheeting. Photograph 9 in Appendix B shows the procedure for handling debris excavated from the anchor trench. Once the FML had been placed in the trench, the stockpiled material was placed back in the trench with the material containing debris below the clay. Any debris that could potentially damage the FML was not placed back into the trench. Instead, this debris was transported to the On-Site Area and placed under the SBPA interim engineered cover. Photograph 10 in Appendix B shows the replacement of clay into the anchor trench.

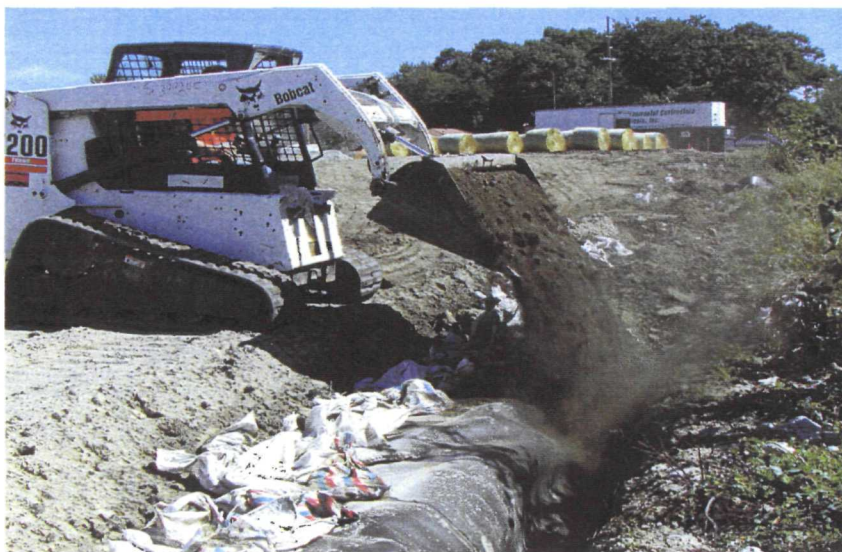
10. September 2002 (Looking East): A low-pressure bobcat is used to place clay back into the anchor trenches around the FML perimeter. The bobcat is then used to compact the clay in the trench.

The replacement of trench material was done so that the material containing debris was covered by at least 12 inches of clay. Because of the potential damage to the FML, a heavy compactor could not be used to compact the clay placed in the anchor trench. Therefore, the compaction standard of 95% of maximum dry density may not have been consistently achieved. Instead, low ground-pressure equipment was used to compact the clay placed in the anchor trench. This provided the compaction necessary to prevent erosion in the trench areas.

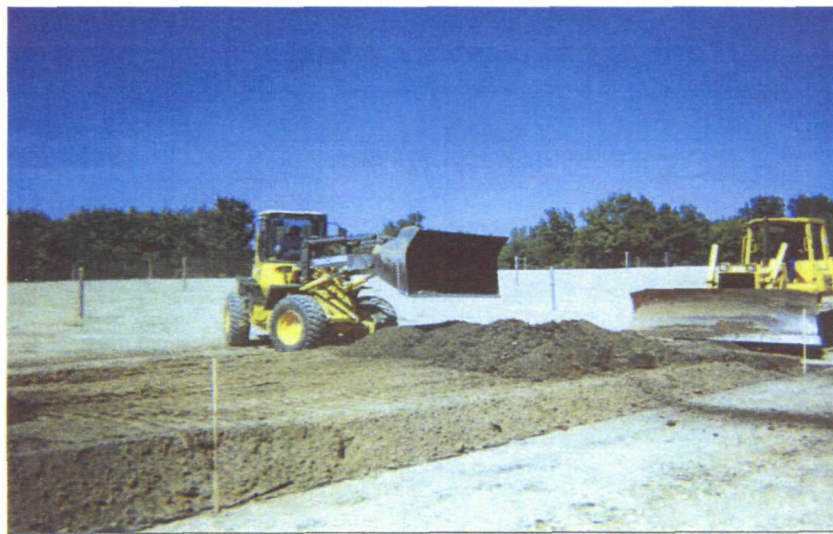
11. September 2002 (Looking West): A test pad is constructed by covering a 23-foot by 65-foot piece of FML liner with 12-inches of root zone and six-inches of topsoil to simulate the actual construction. Heavy equipment is then run back and forth across the test pad to simulate installation methods.

Prior to full-scale installation of FML material, ECI constructed a test pad to verify that the proposed construction equipment and methods used to place the root zone and topsoil material would not damage the FML. The test fill area was the width of one roll of FML, 23 feet wide and 65 feet long. This size allowed the construction equipment to reach the maximum operating speed of eight miles per hour (mph) operating speed over a minimum length of 25 feet.

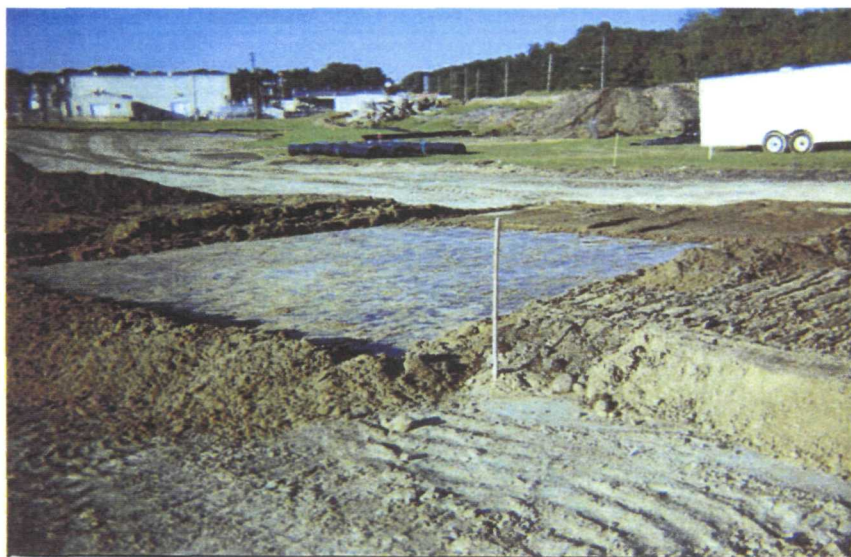
12. September 2002 (Looking North): After the test pad was constructed and subjected to vehicle traffic loading, a section was uncovered and examined for evidence of damage to the FML. No damage was observed.

A fully-loaded off-road dump truck was run back and forth across the 36-inch thick section of the test pad several times. A low-ground-pressure bulldozer was operated back and forth across the 18-inch thick section several times. These were the heaviest pieces of equipment to be used on each section of the Site. After the equipment ran over the test fill sections, a 20-foot by 20-foot section of the FML was exposed on the 18-inch thick section and a 20-foot by 10-foot section was exposed on the 36-inch thick section. ECI and MWH personnel visually inspected each section for damage to the FML. No evidence of damage was noted, indicating that the proposed construction activities could be performed without causing adverse effects to the FML.

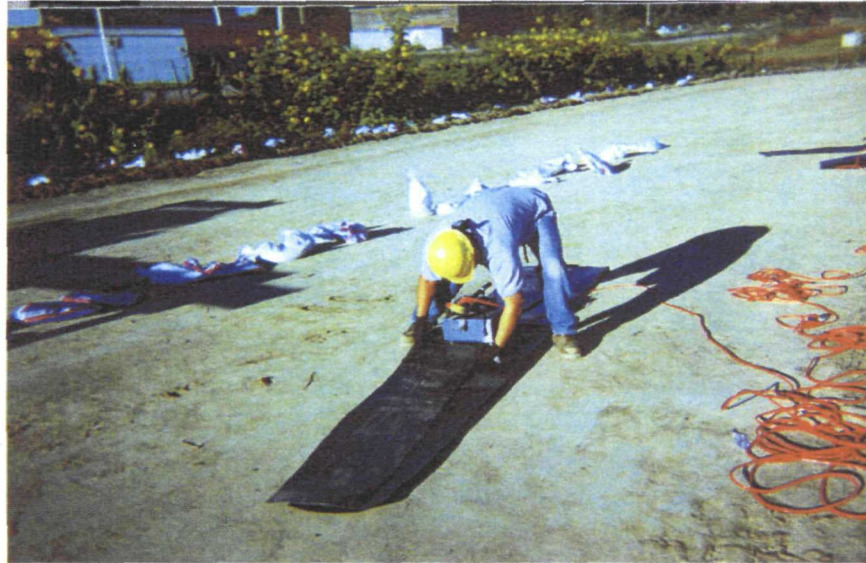
13. September 2002 (Looking Southwest): Trial welds are performed daily by each welding machine and operator prior to beginning and after every four hours of production work.

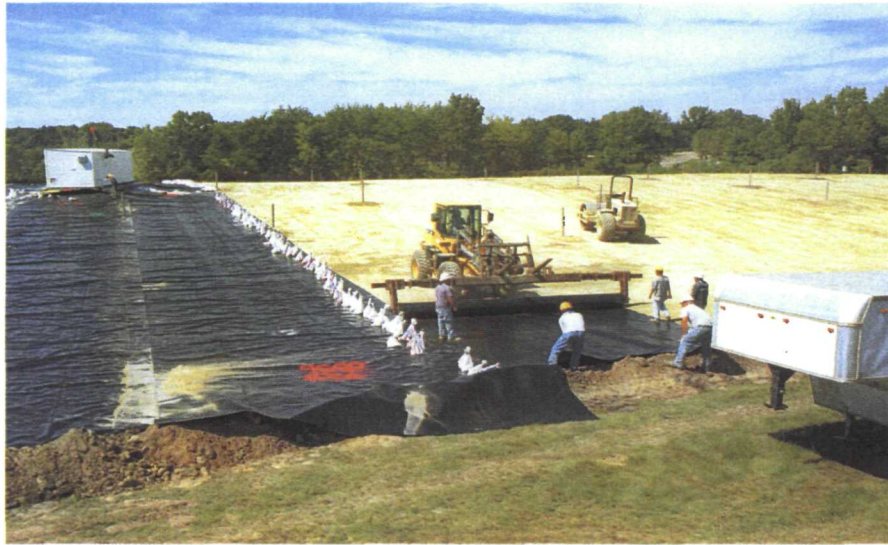
15. September 2002 (Looking West): FML liner is deployed using a special attachment placed on a loader. The liner is unrolled in an east-west orientation by installation crew members. Sandbags are placed along the liner edge to prevent the liner from being picked up by the wind.

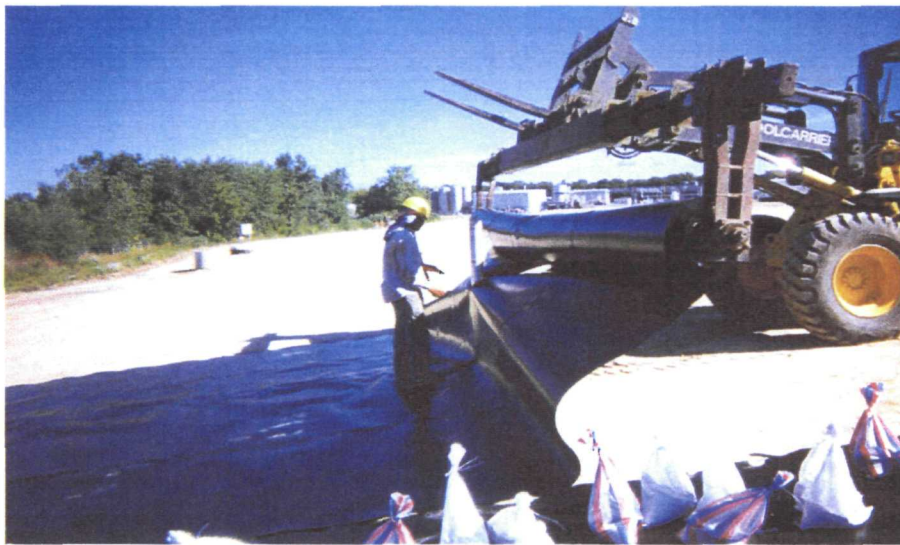
16. September 2002 (Looking North): A hole is cut in the liner as it is placed over each penetration such as an ISVE well. A "skirt" is then placed over this hole and welded to the surrounding liner and to the boot fabricated around each well.

In areas where penetrations to the FML were required, such as ISVE wells, piezometers, and extraction wells, an "x" was cut in the FML so that the FML could be placed over the well or piezometer. A neoprene gasket was placed on the riser pipe and a boot made of FML material was extrusion welded to the gasket. An FML skirt was then welded to the boot and to the FML. A stainless steel clamp was then fastened over the neoprene gasket to ensure the seal at the top of the boot. A detail of those penetrations is shown on Figure 3. The penetrations are also shown in Photograph 18 in Appendix B.

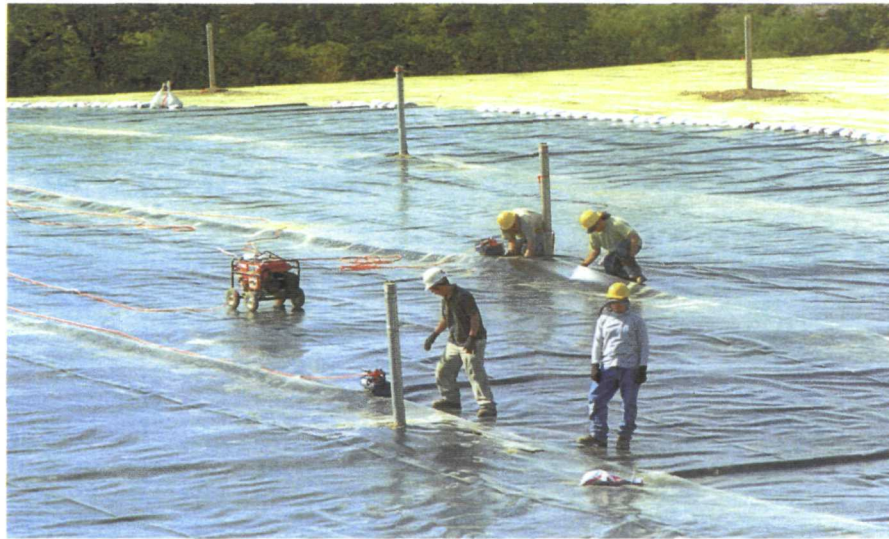
17. September 2002 (Looking Northwest): Adjoining FML panels are overlapped four to six-inches and fusion seamed together.

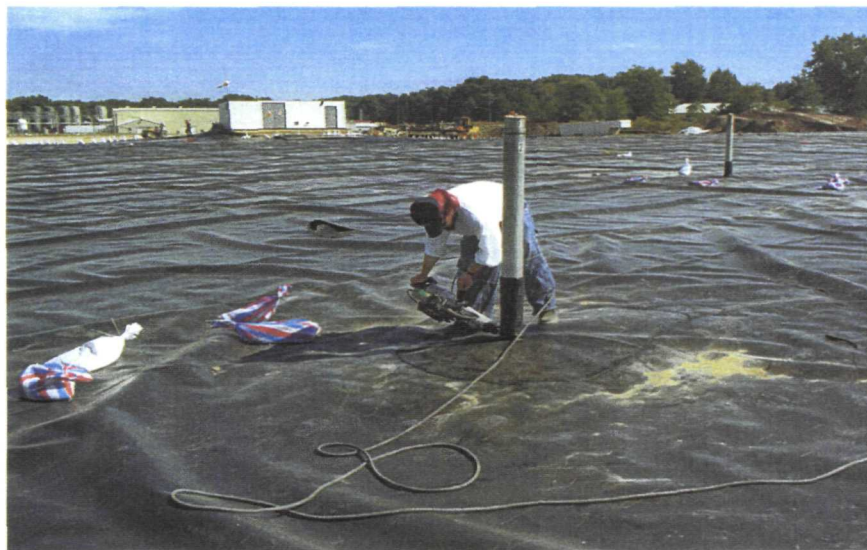
18. September 2002 (Looking North): A crew member grinds the liner surface in preparation for extrusion welding a liner "skirt" around an ISVE well. The grinder roughs the surface to give the extrusion weld a better hold.

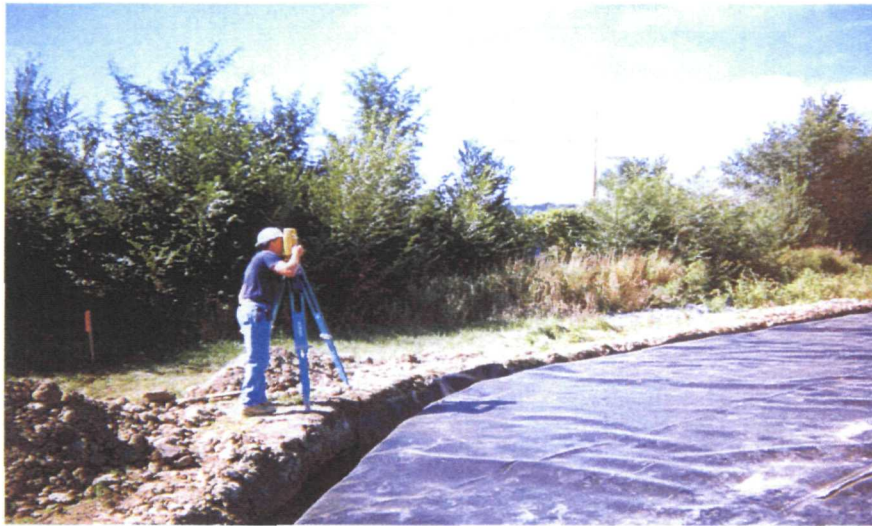
19. September 2002 (Looking South): Surveyors document the liner extents as well as liner panel, seam, testing, and repair locations.

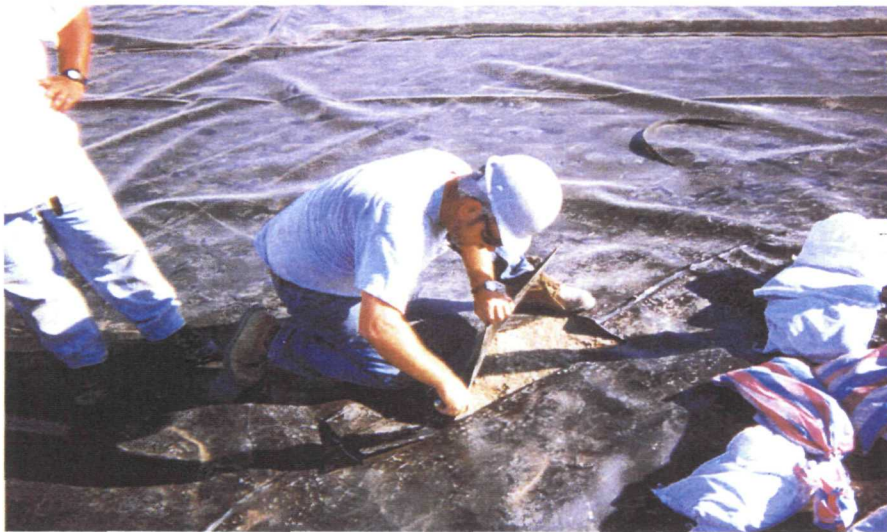
20. September 2002: A sample is cut from a field weld for destructive testing. The sample is tested both in the field and in the laboratory for shear and peel adhesion strength. The area where the sample is cut from is then patched and tested nondestructively.

In addition to the non-destructive seam testing, destructive seam samples were collected every 500 feet of seam and sent to a third party laboratory for seam peel and shear testing. Areas where destructive testing samples were collected were patched and seamed using extrusion welds. Patches consisted of pieces of FML with rounded corners that extended a minimum of six inches beyond the edge of defects or destructive sample areas. Tears, holes, and blisters were repaired with patches as needed. Minor localized flaws were repaired by spot welding or seaming.

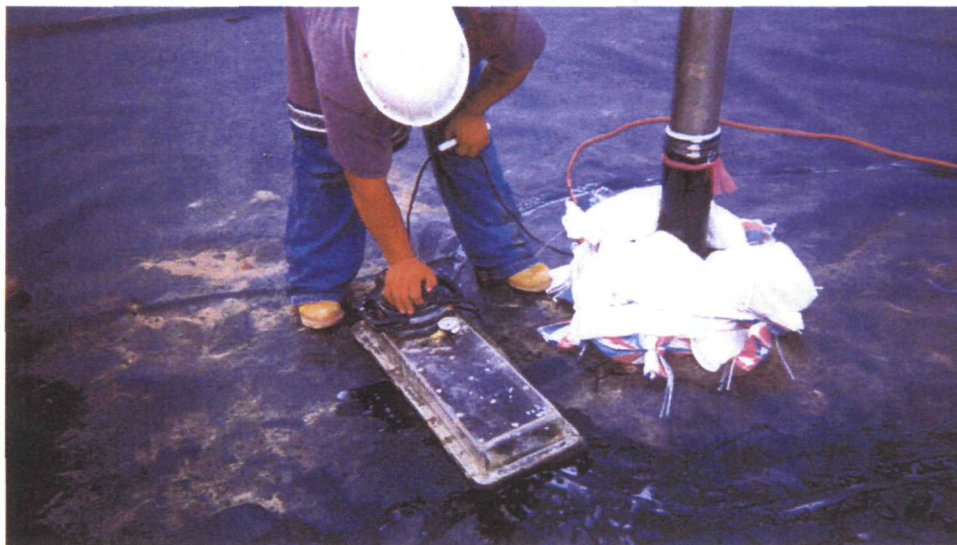
21. September 2002: A vacuum box is used to nondestructively test extrusion welds. Soapy water is first applied to the weld. The vacuum box is then placed over the weld and is subjected to a low vacuum. If soap bubbles form along the weld, the weld contains deficiencies and needs to be repaired.

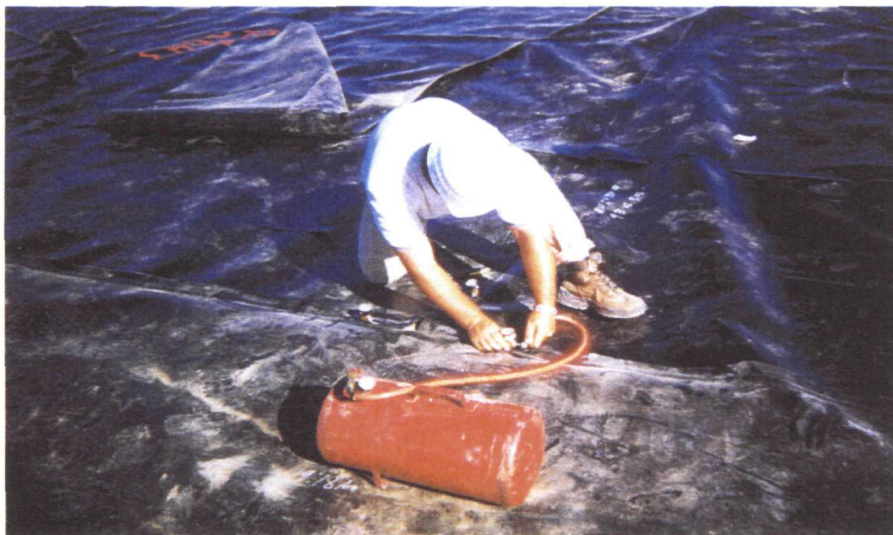
22. September 2002: A fusion weld connecting two adjoining panels is nondestructively testing using a pressure test method. The seam is sealed off at both ends and pressurized to at least 25 pounds per square inch (psi). To pass, the seam pressure must not vary by more than four psi over the five minute testing period.

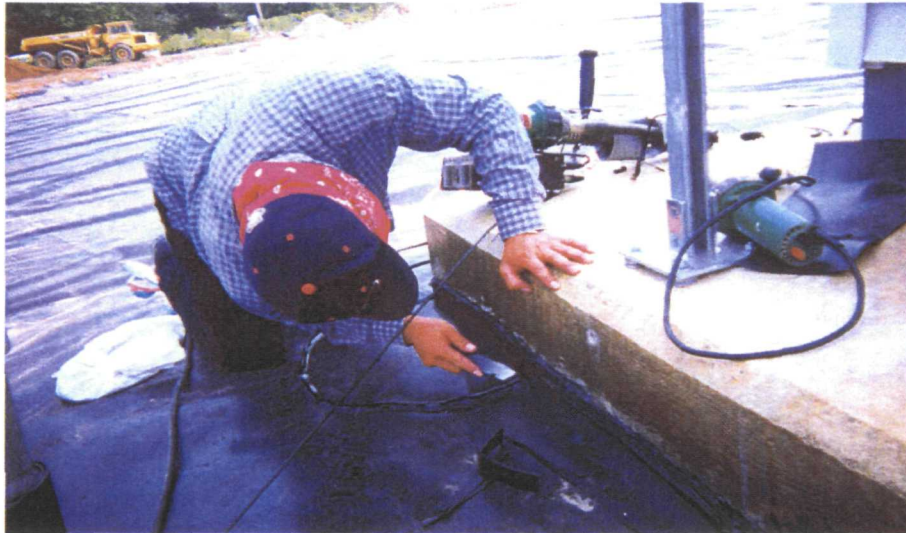
23. September 2002 (Looking East): A liner crew member applies extrusion welding around the foundation of the blower shed. The liner is welded to a continuous FML embedment strip along the blower shed foundation.

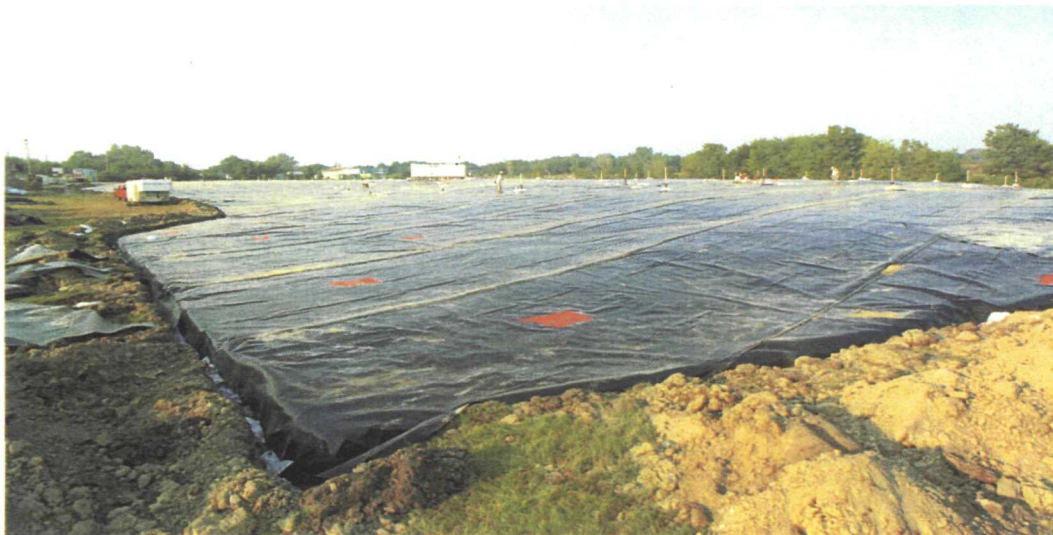
24. September 2002 (Looking South): The liner is placed in the perimeter anchor trench and later covered with clay, root zone, and topsoil.

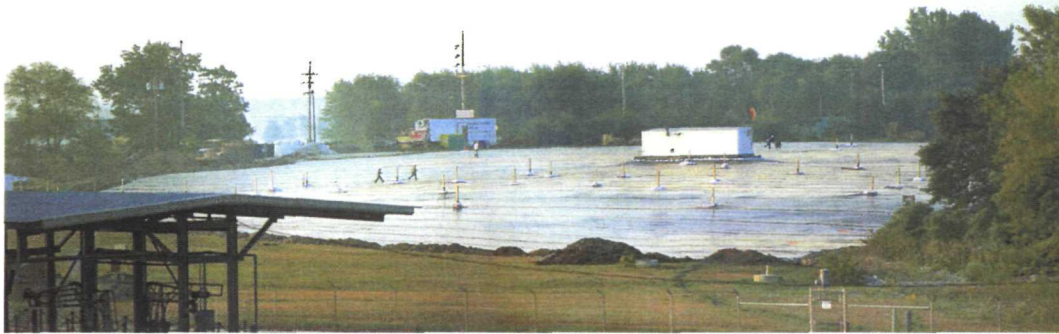
25. September 2002 (Looking Southeast): An view of the completed FML liner.

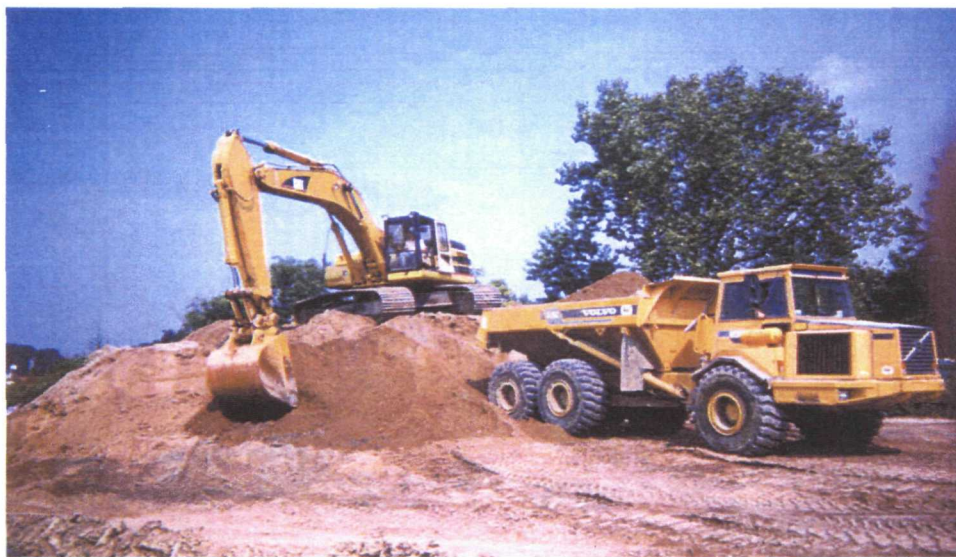
26. September 2002 (Looking North): An excavator loads previously stockpiled wetland sand material into an off-road dump truck from the Off-Site Area stockpile for use as root zone.

yards, root zone material was imported from a borrow source in Merrillville, Indiana (Material Number 2) until that source was also exhausted. The Merrillville source accounted for approximately 5,115 cubic yards of material. Finally, ECI imported approximately 4,162 cubic yards of material from a borrow source in Griffith, Indiana (Material Number 3). ECI completed placement of root zone material over the FML on September 26. Compaction and moisture testing was completed on October 1. Photographs 26 through 30 show the activities involved with the root zone placement.

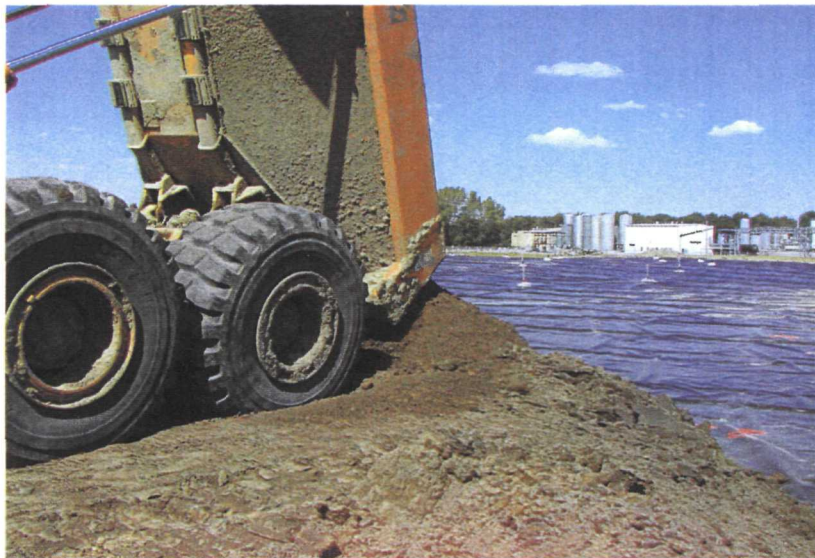
27. September 2002 (Looking North): Wetland sand material is placed as root zone in the southern portion of the Off-Site Area.

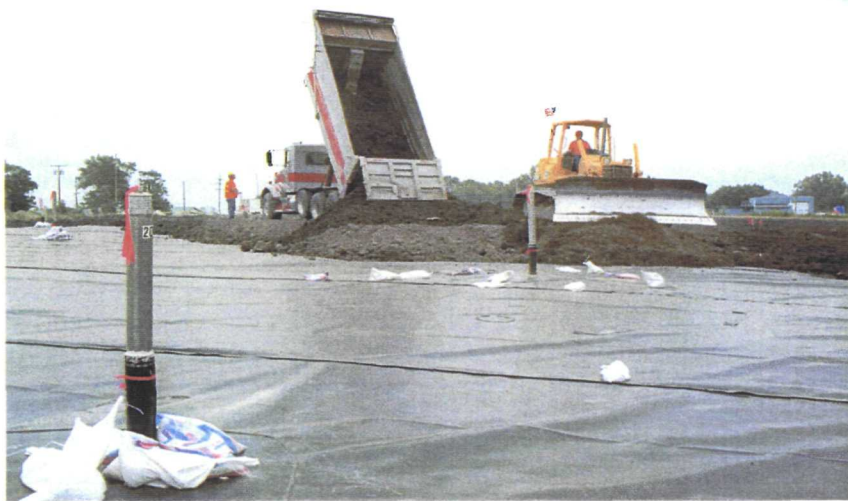
28. September 2002 (Looking Southeast): Material is also imported from two off-site locations (one in Merrillville, one in Griffith) for use as root zone. A dozer spreads the root zone over the installed liner in one 12-inch lift.

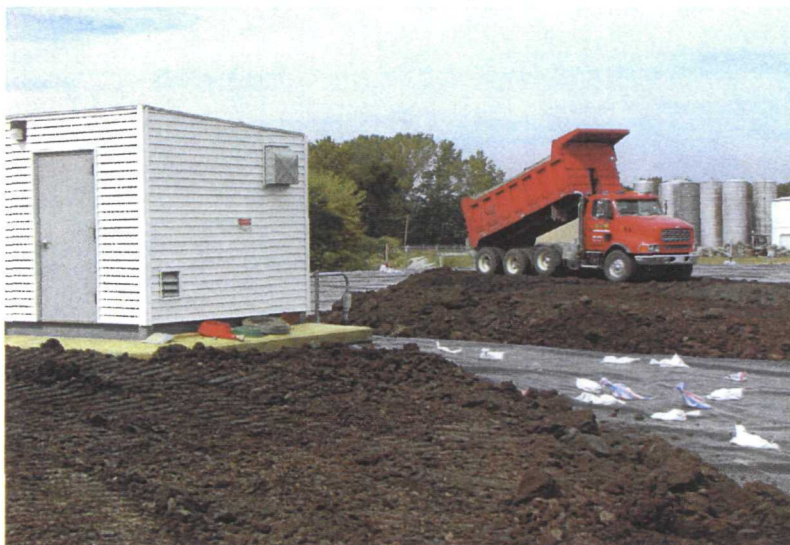
29. September 2002 (Looking Northwest): A temporary access road is first constructed of root zone material to allow dump trucks to enter the FML liner area to place imported root zone material.

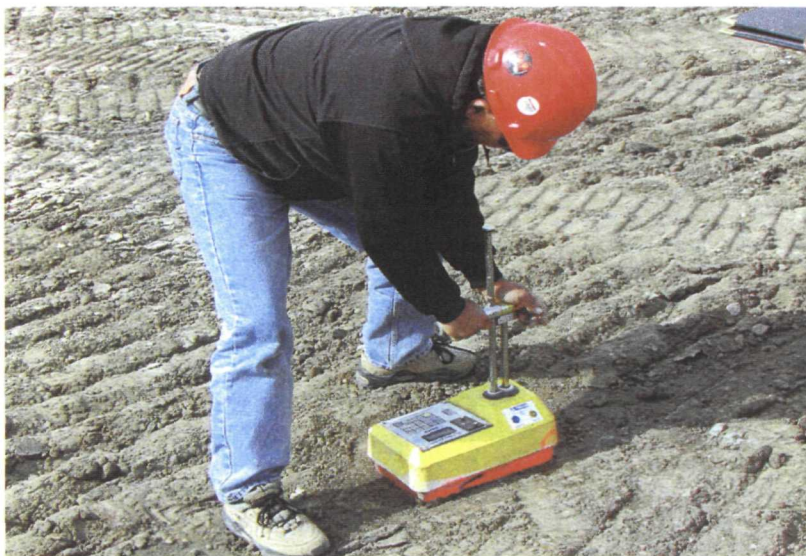
30. September 2002: A nuclear density testing unit is used to test the moisture content and compaction at various locations across the root zone area.

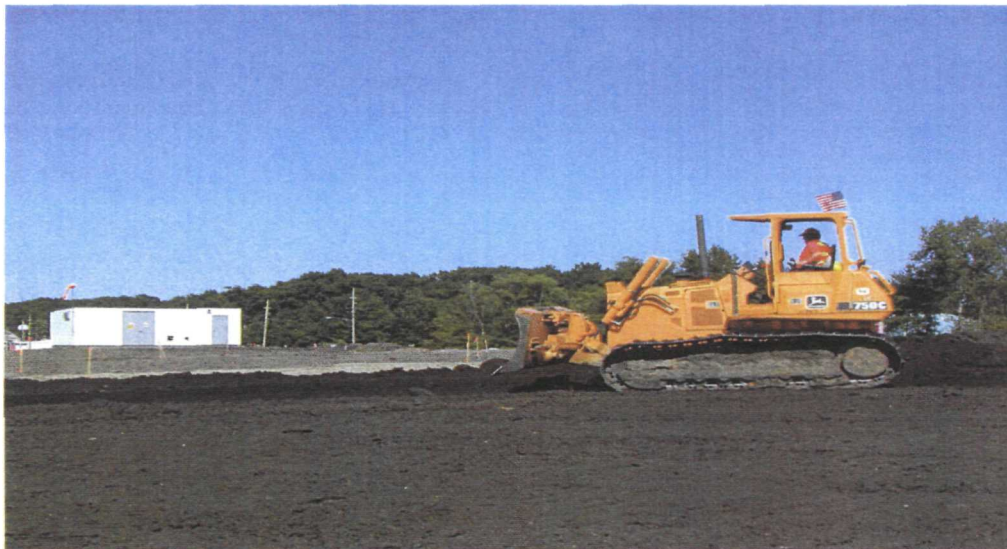
31. October 2002 (Looking Northeast): Six-inches of imported topsoil is placed on top of the root zone over the entire FML Cover Area.

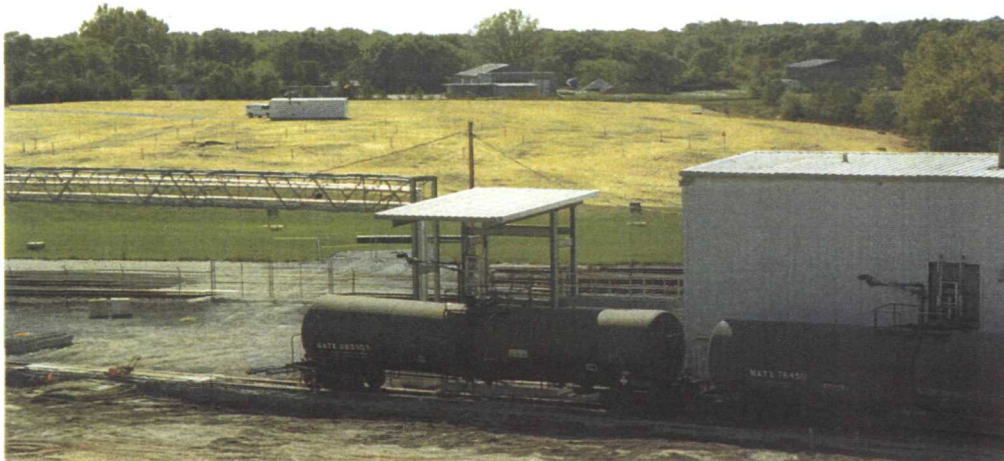
32. October 2002 (Looking South): A view of the completed Off-Site Area Final Engineered Cover. Topsoil and grass seed have been placed over the entire FML Cover Area. Yellow straw is visible, placed over the grass seed as erosion control.

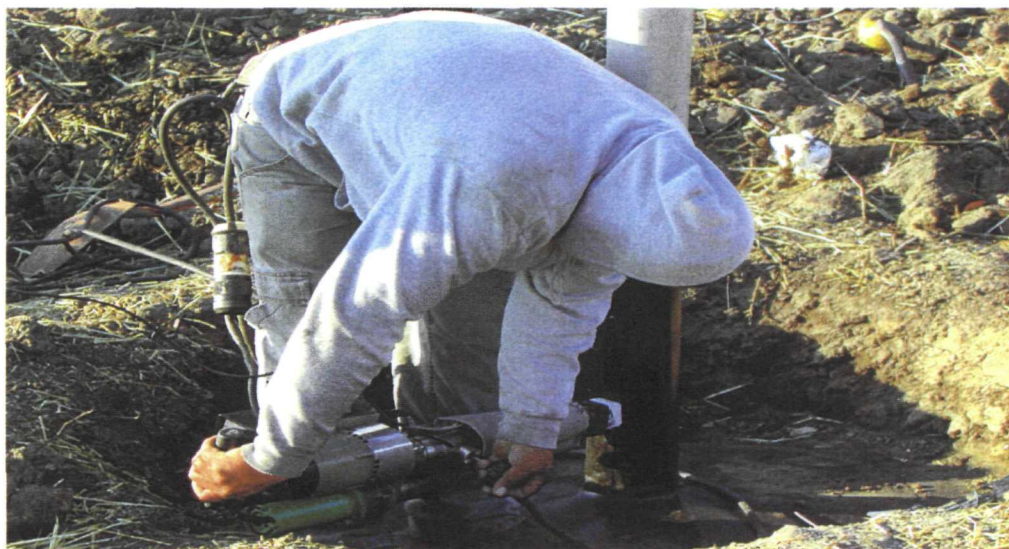
33. October 2002 (Looking Southwest): Seaming the new boot and skirt on ISVE well, SVE-38, after the well casing has been repaired.

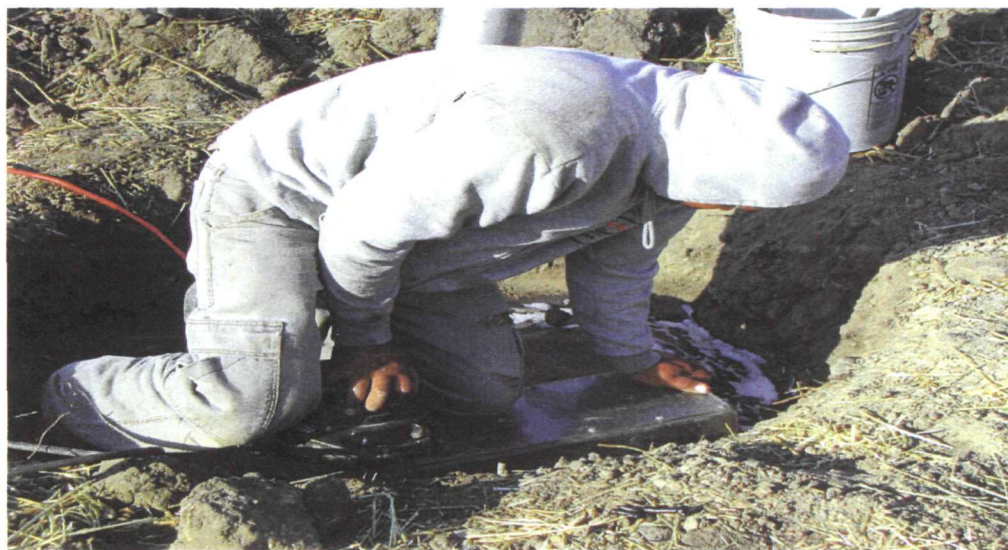
34. October 2002 (Looking Southwest): A vacuum box test is performed on boot and skirt on the repaired ISVE well, SVE-38.

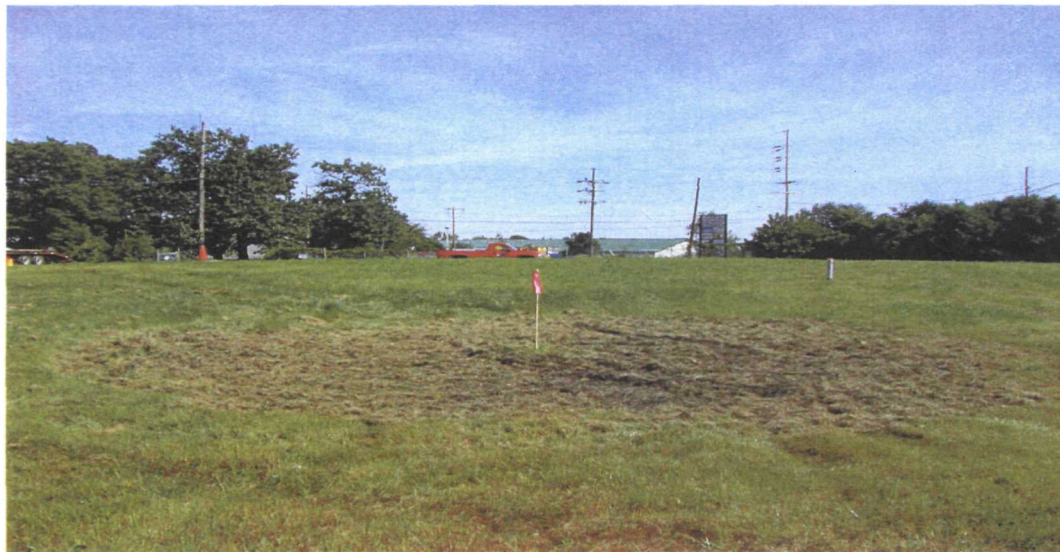
35. August 2003 (Looking East): Area with deficient topsoil thickness after it has been scarified.

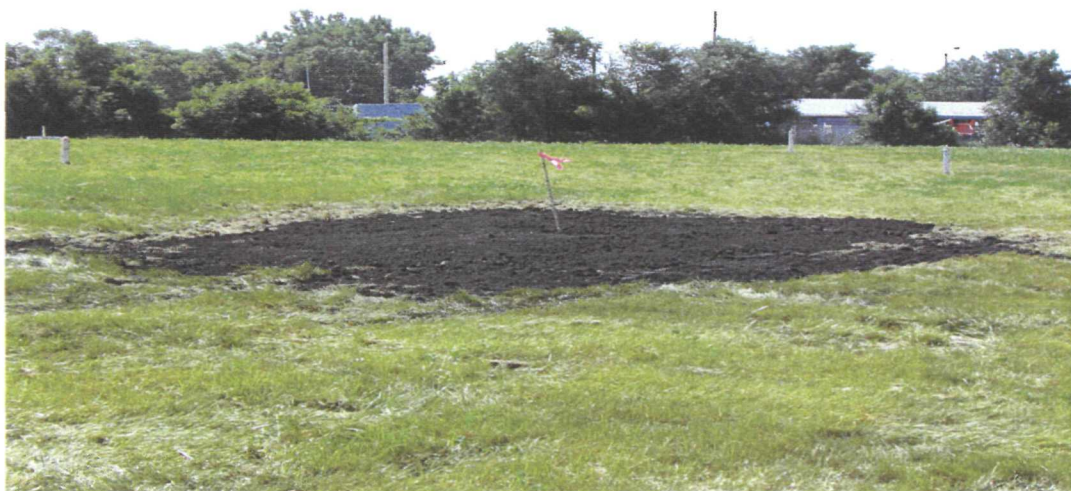
36. August 2003 (Looking Southeast): Area with deficient topsoil thickness after additional topsoil has been placed.

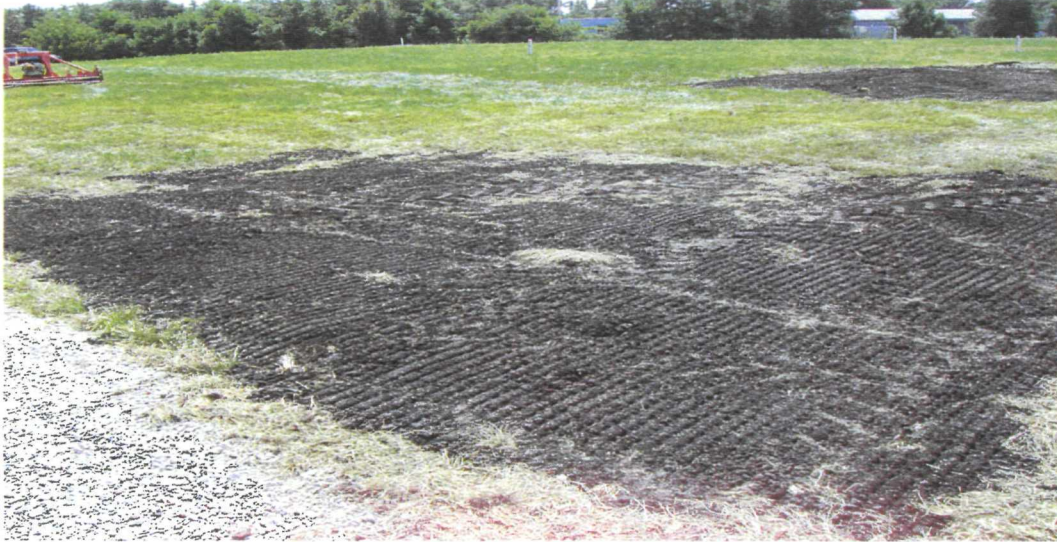
37. August 2003 (Looking Southeast): Area with previously deficient topsoil thickness after being raked and seeded.

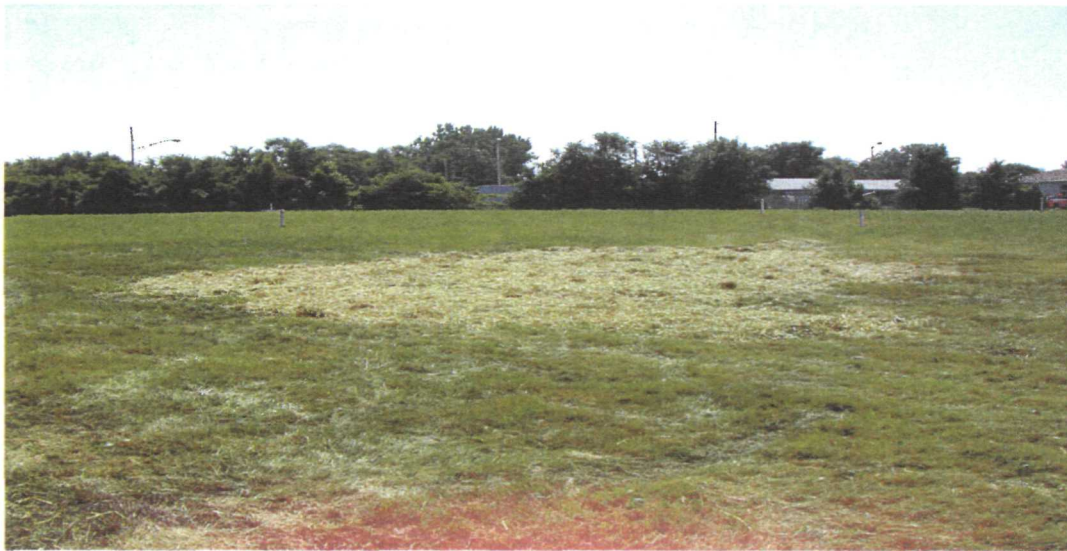
38. August 2003 (Looking Southeast): Area with previously deficient topsoil thickness after straw is placed over the seeded topsoil.
